NASA Technical Paper 1425

Industry Tests of NASA Ceramic Thermal Barrier Coating

Curt H. Liebert and Francis S. Stepka

JUNE 1979

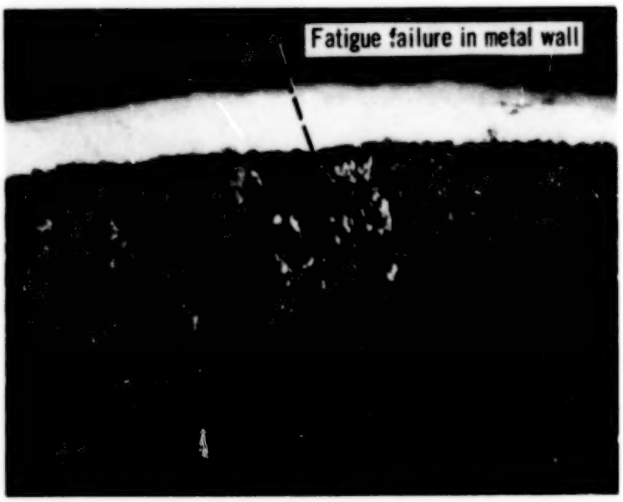
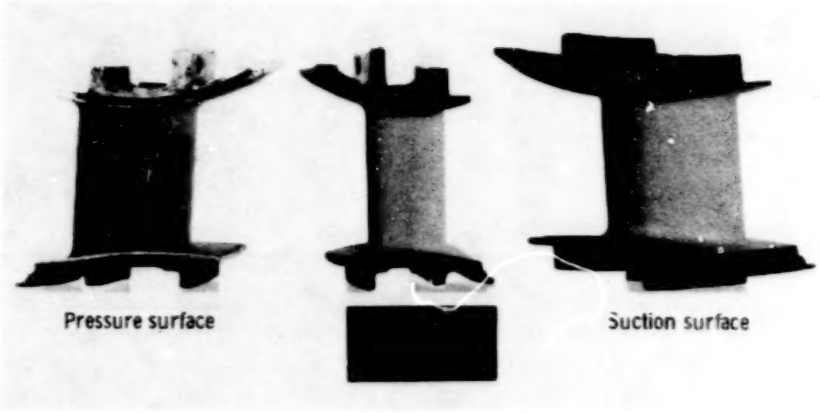
Figures 4(d) and (e) show a cross section of the coated blade. Fatigue failure occurred in the blade metal wall, not in the TBC, even though both bond and ceramic coating thicknesses were at their maximum in this airfoil location. The TBC did not spall in any area of the airfoil during this test. These results provided the confidence to install and test four blades coated with the TBC in a military aircraft engine. The test results are discussed later (see p. 7 and objective III-A-2, table I).

(d) Metal wall fracture of coated turbine blade after tests. ×20.

(e) Metal wall fracture of coated turbine blade after tests. ×20.

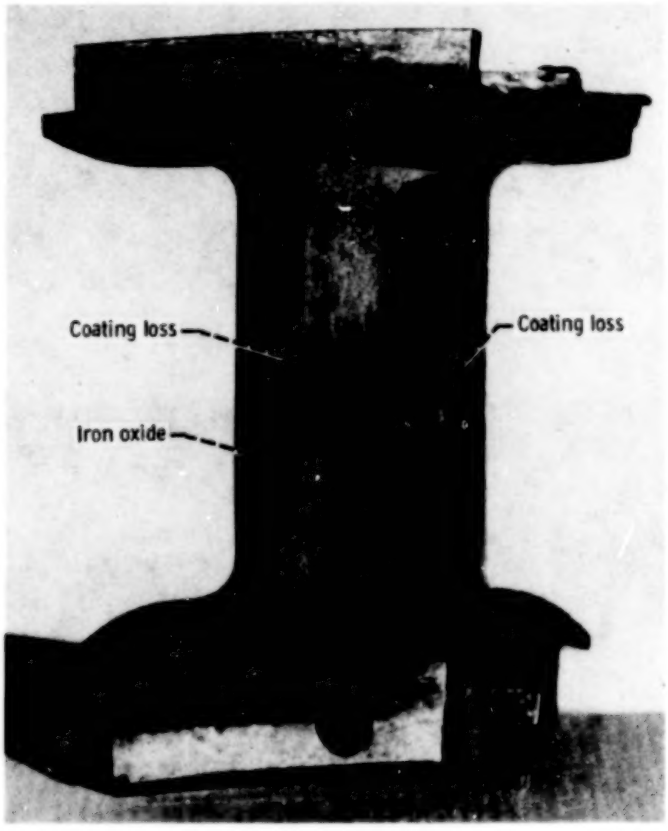
Turbine vanes - military aircraft engine. - An uncoated vane located in a hot-gas region (about 1700 K) melted and burned during accelerated cyclic endurance tests in a military aircraft engine (objective III-A-1, table I). This occurred during the first 60 hours of bimodal cyclic operation which included 240 cycles between the average gas temperature (1550 K) and shutdown and 1920 cycles between the average gas temperature and idle. This vane was replaced with a coated vane of identical design (fig. 5(a)) and subjected to the same test conditions. After 60 hours of these cyclic tests, the metal wall of the coated vane was not distressed, but loss of the TBC was observed at the trailing-edge pressure surface aft of the cooling-air dump holes (fig. 5(b)) and in small areas at the leading edge. Because the metal wall was very thin at the trailing-edge region, it could only be lightly grit blasted (about half the normal blasting pressure). This could be partly responsible for the premature coating deterioration in this region.

To improve durability, another vane of identical design was coated (after only a light grit blast), vacuum heat treated, and then tested at the same engine conditions. Visual inspection of this vane after 100 hours of testing showed no deterioration of the TBC. This test time included 400 and 3200 cycles of the two types just described. Testing continued with this vane for a total of 300 hours; this included 1200 and 9600 cycles at each of the two types of cycles. Visual inspection after 300 hours showed minute coating loss at the leading- and trailing-edge regions, but no deterioration of the cooled metal wall. Iron oxide particles were deposited on the TBC during the test (fig. 5(b)). Iron oxide (Fe_2O_3) can react with yttria-stabilized zirconia in the TBC (when monoclinic ZrO_2 is present) over times of 200 to 800 hours and temperatures of 1473 to 1673 K (ref. 21). Since the coating operated in this temperature range and is presumably partially monoclinic, such a reaction may be partly responsible for the deterioration of the TBC after 300 hours of cyclic operation.

(b) After tests.

The better durability of the coating on this vane is attributed to the vacuum heat treatment which sintered and densified the bond coating to improve its oxidation resis-

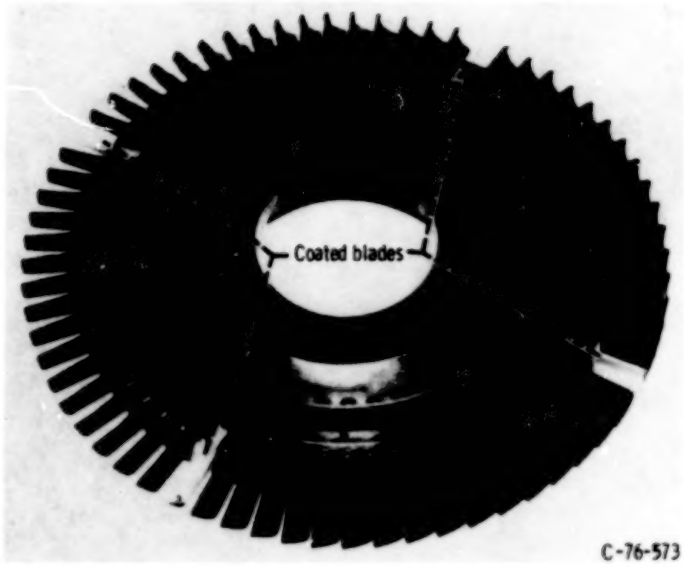
Figure 6. - Four coated military engine blades before tests.

Turbine blades - military aircraft engine. - The TBC on four convection-cooled core-turbine blades installed in the rotor of a military aircraft engine are shown in figure 6 before the start of "piggy-back" tests (objective III-A-2, table I). Boroscope inspection of the leading edges of the four coated turbine blades showed no evidence of deterioration after 10 hours of testing (ref. 22). These tests were at a gas temperature and pressure of 1640 K and 2.5 megapascals, respectively. After 15 hours of operation, an aluminide coating on the blades without the TBC showed some evidence of wear, but the TBC showed no signs of wear. Testing of the coated blades is continuing.

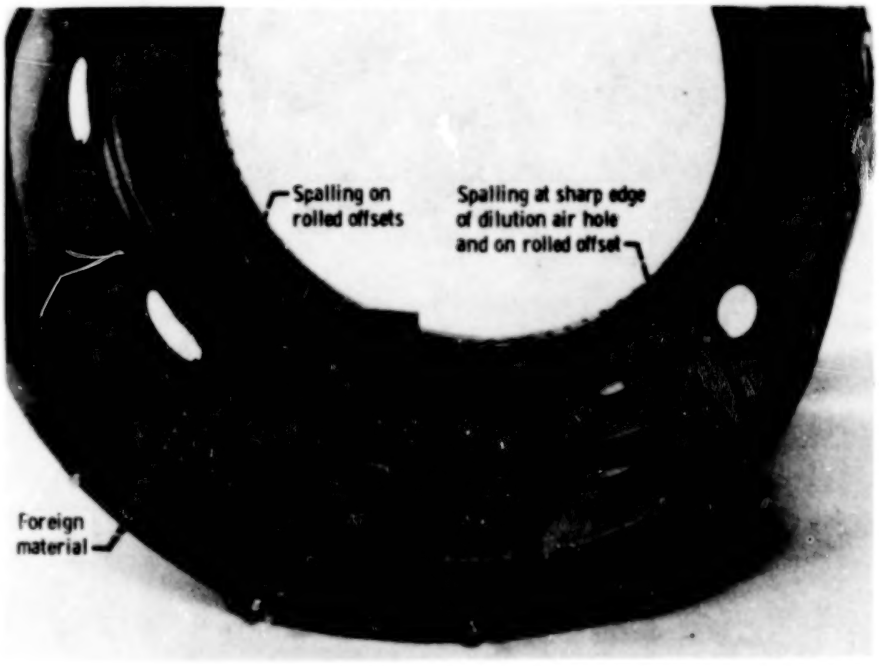
Combustor liner - auxiliary power unit. - Heat-transfer calculations showed that the experimental combustor liner designed for use in the auxiliary power unit (objective III-A-5, table I) would probably distort during planned performance tests unless a TBC was used. The TBC was plasma-sprayed onto the gas-side surfaces of two combustor liners. Figure 7(a) shows the first coated liner before performance testing. Inspection of this liner after 15 hours of testing at measured hot-spot, coated metal temperatures of 1300 to 1370 K showed no liner warpage and no deterioration of the TBC. The gas conditions for these tests were more severe than required for the current gas-turbine engine. Tests were conducted on the second liner which had a more complex geometrical design. After 6 hours of testing, the TBC flaked off in the region where rolled offsets were fabricated into the sheet metal of this liner (fig. 7(b)); however, there was no liner warpage. The metal temperatures in this region were about 1140 K. These tests again showed the protective capability of the TBC, and they showed that the adherence of the coating is reduced when placed in regions where there are rapid changes in metal shape (the rolled offsets).

(b) Second coated combustor liner with a more complex geometrical design after tests.

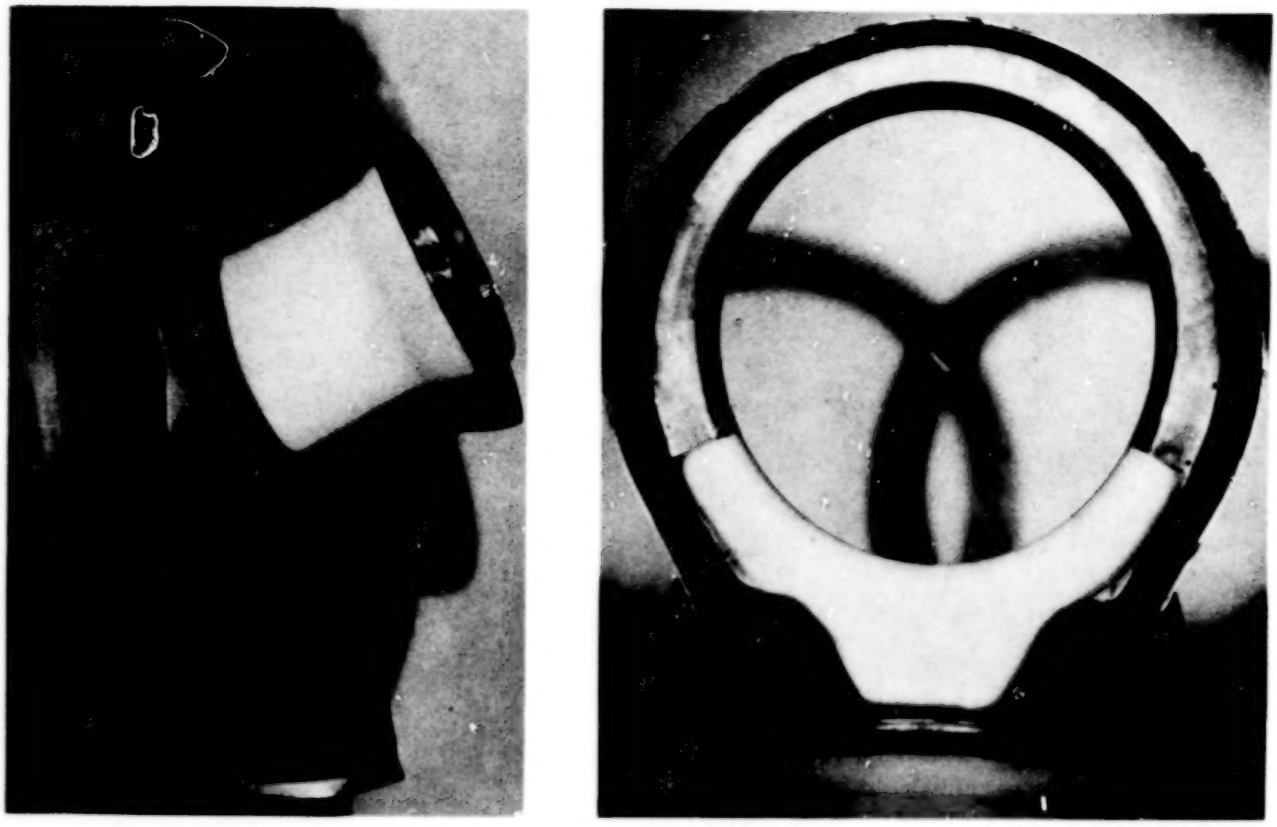
Figure 7. - Coated combustor liners of auxiliary power unit.

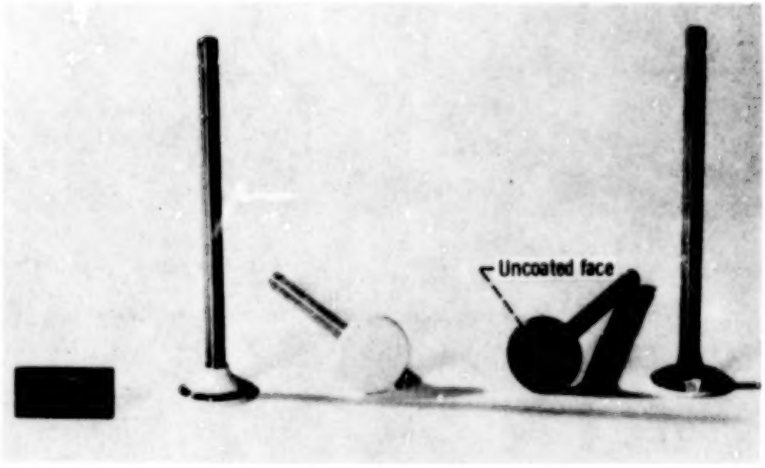
Figure 9. - Coated and uncoated diesel engine valves before tests.

There was no measurable thermal-barrier benefit of the TBC on the valves (fig. 9) as determined from the tests of the supercharged diesel engine (objective III-B, table I). The cooling effect of the scavenging air on this two-cycle engine is apparently sufficient to nullify the insulation provided by the ceramic coating. Both uncoated and coated metal temperatures were about 920 K. Examining the ceramic coating after the 1-hour engine test showed that (1) the thick (0.18 cm) layer of ceramic on the thick (0.25 cm) substrate adhered well and (2) there was no deterioration in this environment.

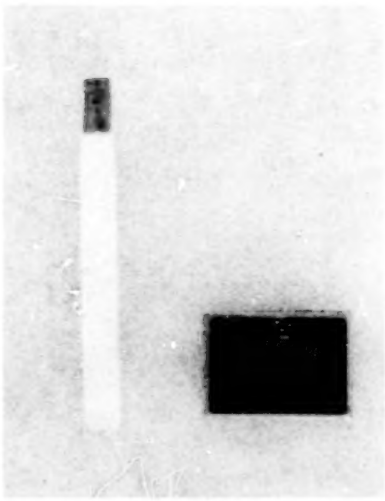
Figure 10. - Coated solid pin specimen for corrosion protection and durability tests in marine diesel fuel products of combustion.

Coated pin-type specimens similar to the one shown in figure 10 were used to investigate the corrosion protection and durability of the TBC and its ability to protect base metal parts from corrosion in marine diesel fuel products of combustion (objective IV-A, table I). The tests with the burner rig simulated coating operation on marine gas-turbine engines. One specimen withstood 1000 hours (40 cycles) of testing. A cycle consisted of 23 hours at a gas (and metal) temperature of 978 K with a 2-hour cooldown period to 300 K. Nominal, polished zirconia thickness before testing was 0.038 centimeter, and metallographic examination showed that about 0.008 centimeter of yttria-stabilized zirconia was lost during the test. The TBC on the second specimen cracked and spalled after 322 hours or 14 of these cycles. The other two specimens were heated with this rig from about 300 to 1070 K and then cooled to 300 K. One of these specimens ran for 450 hours, and the other specimen was tested for 800 hours before cracking and spallation occurred. Metallographic examination showed no base metal deterioration on any of the four specimens. The results of these corrosion protection and durability tests indicated that the TBC is as good as some other coating systems also tested at these cyclic conditions.

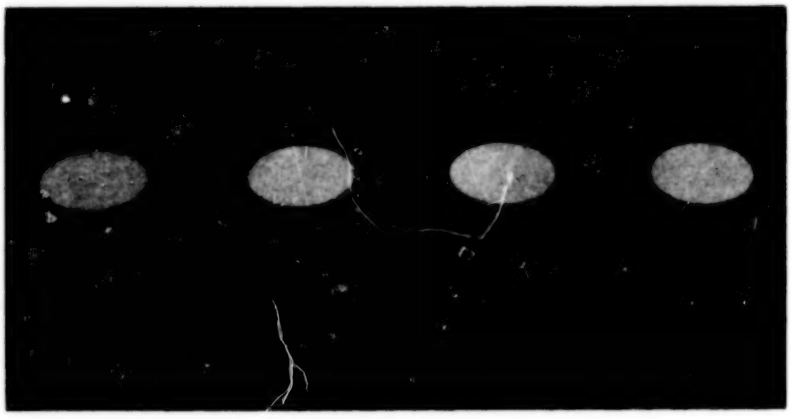
Figure 11. - Coated disks for tests to simulate lava drilling.

The results of the tests at 1256 K indicated that molten glass diffused into the TBC, acted as a flux, and melted the ceramic. Therefore, the TBC cannot be used in this application.
